Seepage Loss Test Results In Hidalgo County Irrigation District No. 2¹

Hidalgo County Irrigation District No. 2

Eric Leigh and Guy Fipps, P.E.²

November 5, 2002

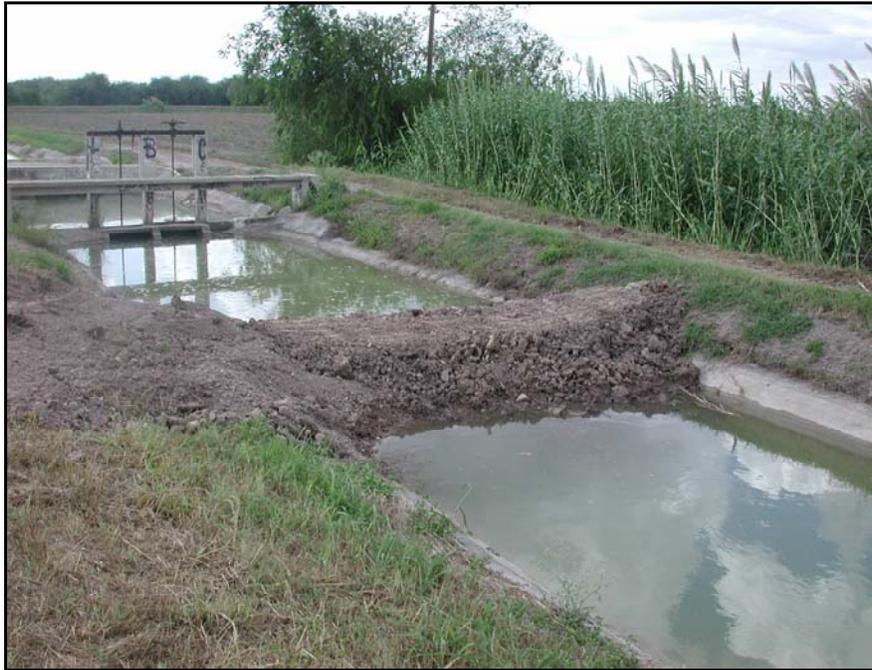
Figure 1. Earthen dam constructed on lateral A - Stewart Rd.

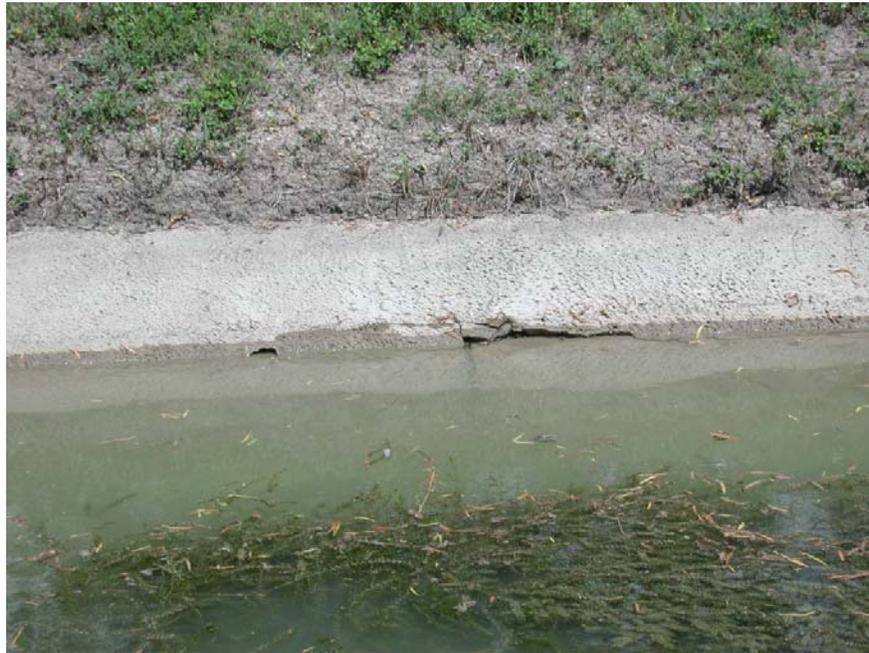
Figure 5. Large crack in the canal lining and aquatic vegetation growing from the bottom of the canal (lateral A - Stewart Rd)

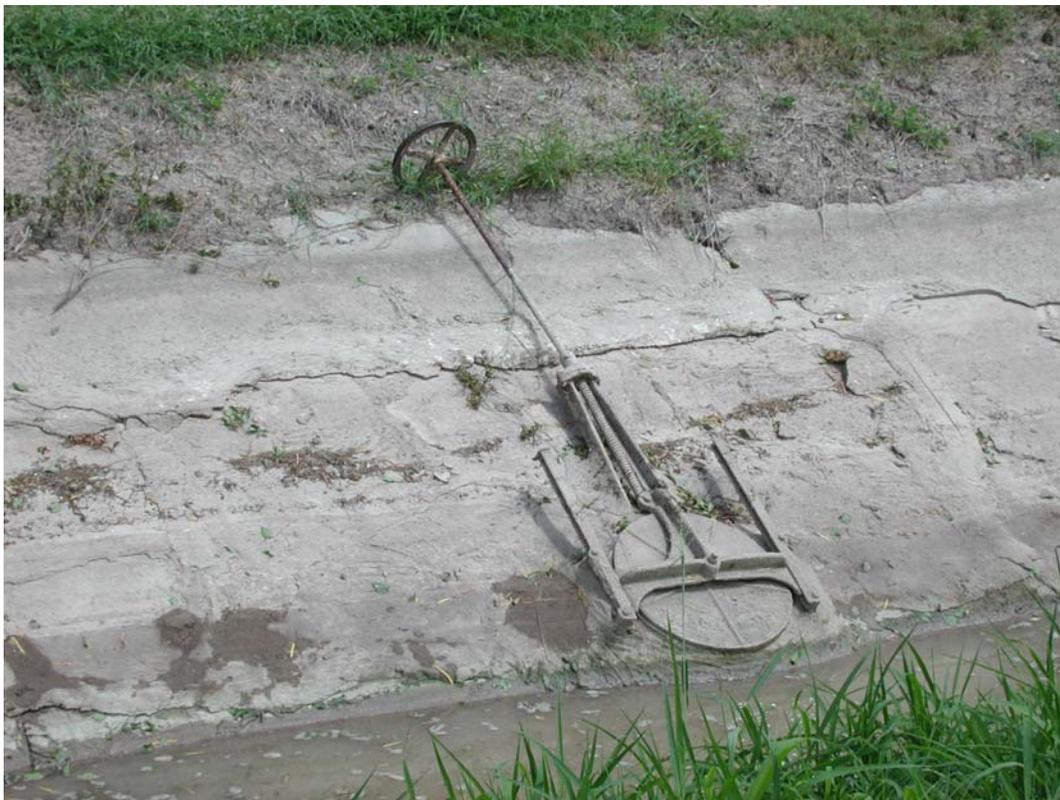
Table 2 gives additional data and information on the test of Lateral A- Stewart Rd. Given are canal dimensions, testing dates and time, and stage level measurements. Figures 6, 7 and 8 show the measured canal profile, which is compared to an ideal canal profile. The ideal profile was developed by fitting an equation to the measured data as shown. Table 3 gives the loss rated in 4 methods commonly used to characterize water loss in canals. Annual water loss rates assume that the canal is in service 365 days per year. Figure 9 shows cracks in Lateral A, which are characteristic of this segment.

Figure 9. Cracking of lateral A - Stewart just down stream of the test section.

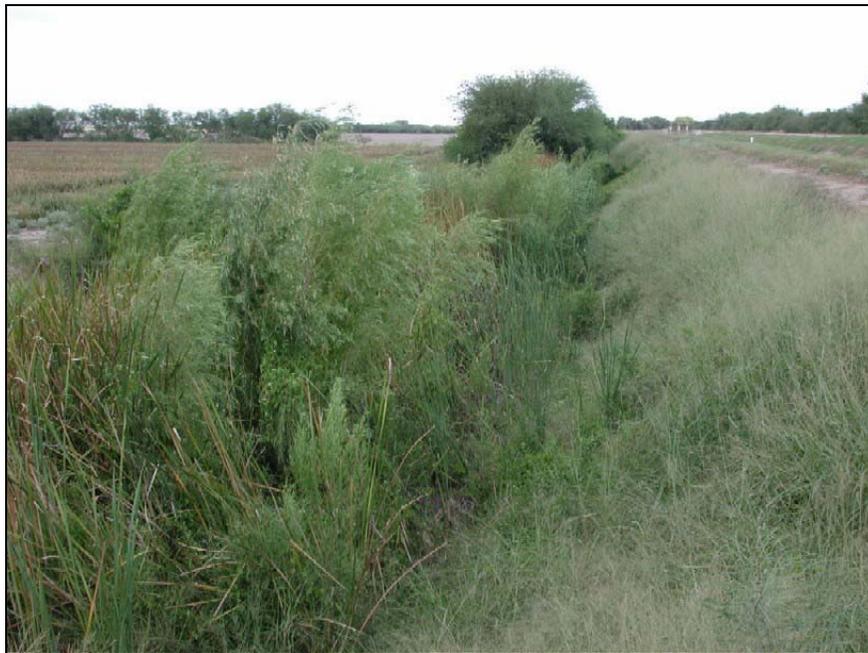
Figure 12: Large amounts aquatic vegetation growing next to lateral A - I Rd.
