**Thermal Imaging of Canals for  
Remote Detection of Leaks:  
Evaluation in the United Irrigation District<sup>1</sup>**

Yanbo Huang and Guy Fipps, P.E.<sup>2</sup>

December 20, 2002

## **Thermal Imaging of Canals for Remote Detection of Leaks: Evaluation in the United Irrigation District**

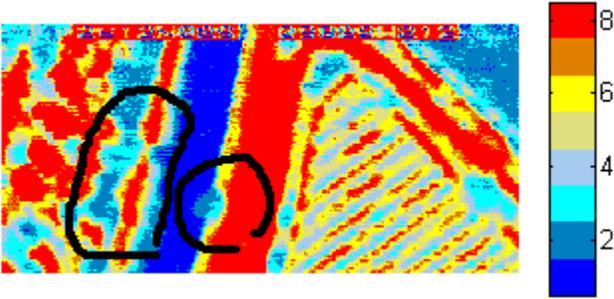
Figure 2a. Site 1 - Original processed image.

As seen in figure 2a, on one side of the canal (right side on the image) there is a wide strip which is likely a dirt road on the canal levee. On the same side beside the canal, an area showing the possibility of wetness or vegetation (mark circled on the right of the image). On the other side of the canal (left side on the image), there is another area of vegetation and/or wetness and a narrow dirt road (mark circled on the left of the image).

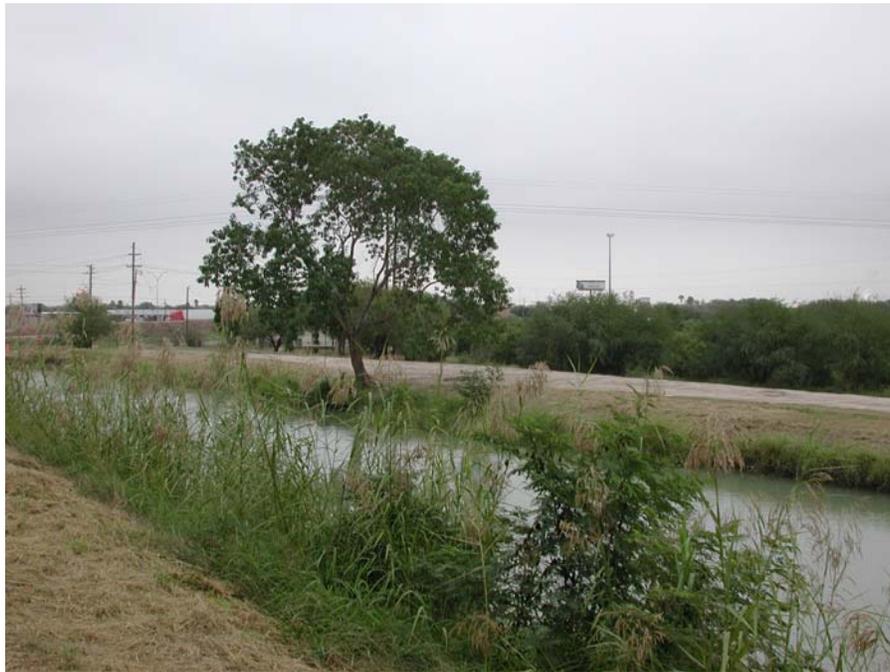
Figure 2c. Photograph of Site 1 – an unlined canal segment with a hole in the embankment.

- Wetness: 2
- Vegetation:
  - Grass – 2
  - Trees – 2
  - Crops – 0
- Seepage: 2
- Cracks: 0
- Holes: 2

Photographs taken at this location show a large tree and the dirt road on the same side of the canal (Fig. 2c). Water appears to be flowing out of the canal through a large hole located near the tree. Figure 2d shows thick vegetation (grasses and bushes) with a narrow stripe of dirt road. The site evaluation matched very well our interpretation of the thermal imagery.

***Conclusion: this canal segment has a severe seepage problem at this location caused by a hole in the canal..***

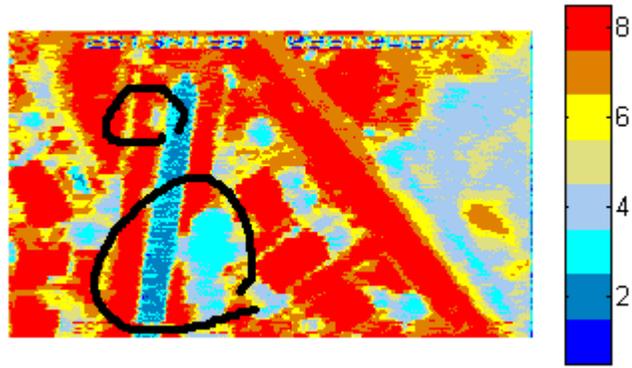
Figure 3a. Site 2 - Original processed image.

As shown in Figure 3a, the thermal image shows two areas of wetness (mark circled on the image) on either side of the canal. Figure 3b shows the inverted image overlaid onto the DOQQ (figure 3b). The results of the field evaluation are as follows:

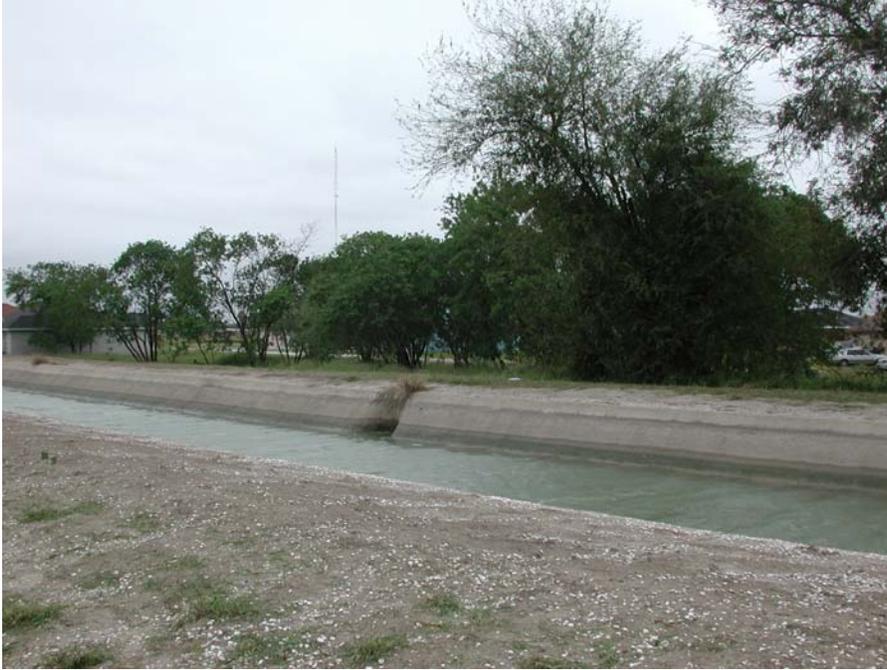
Figure 3c. Site 2 – thick vegetation along the canal.

- Wetness: 1
- Vegetation:
  - Grass – 2
  - Trees – 2
  - Crops – 0
- Seepage: 1
- Cracks: 1
- Holes: 0

Site photographs (Fig. 3c-d) show a structure on the side of the canal which appears to be an abandoned gate through which water is flowing. As this is the only place along the canal with thick vegetation, the abandoned gate is likely the only source of the leak.

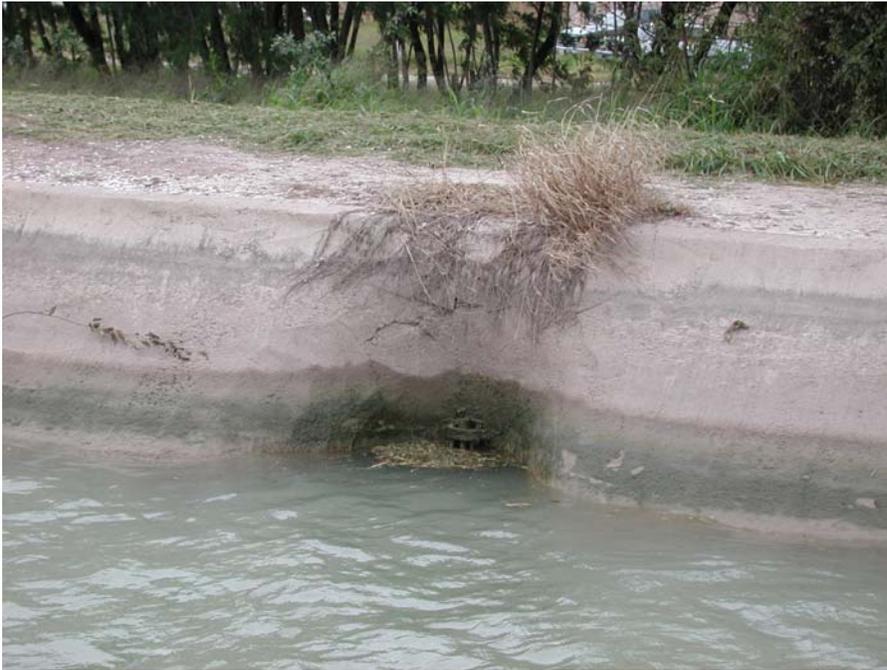
Figure 3d. Site 2 – an abandoned gate associated with the area of thick vegetation.

***Conclusion: thermal imaging clearly identified the source of a significant leak being caused by an abandoned gate.***

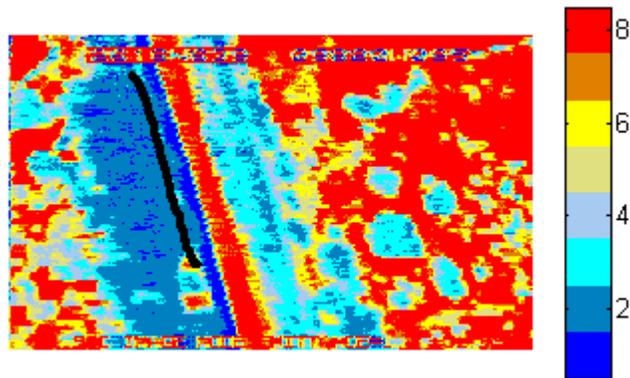
Figure 4a. Site 3 - Original processed image.

As shown in figure 4a, there is likely a seepage area along one side of the canal (left side on the image). The rating of this site is as follows:

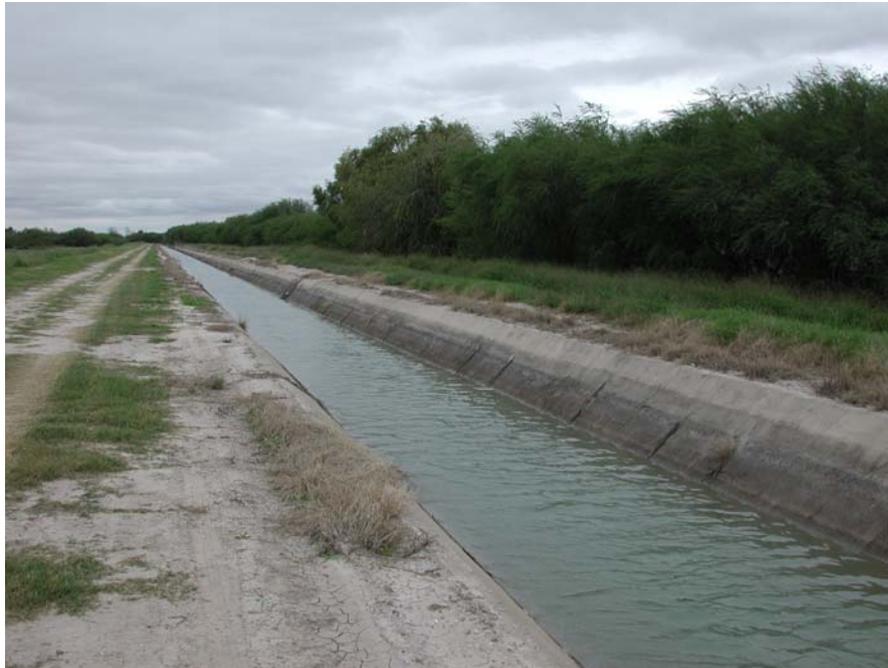
Figure 4c. Site 3 – showing cracks and thick vegetation on one side of the canal.

- Wetness: 0
- Vegetation:
  - Grass – 2
  - Trees – 2
  - Crops – 0
- Seepage: 0
- Cracks: 2
- Holes: 0

The field photograph (Fig. 4c) shows thick vegetation on the side of the canal having and many cracks. Some of the cracks are sealed but others are not. These unsealed cracks appear to be the cause of the seepage from this canal segment.

***Conclusion: thermal imaging detected seepage caused by cracks in a canal.***

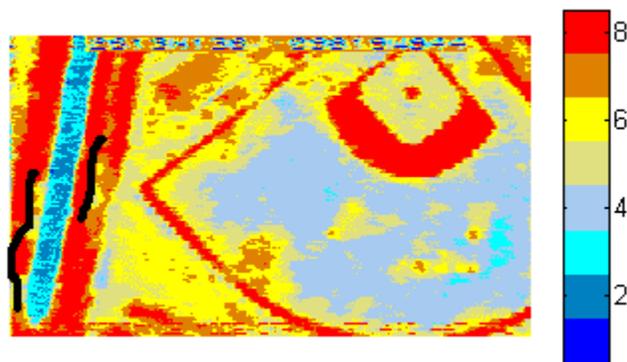
Figure 5a. Site 4 - Original processed image.

Figure 5a shows a canal segment beside a baseball field. While there is no indication of vegetation or wet areas along this segment, there is something other than a dirt road (line-marked on the image). This image was inverted and overlaid on the DOQQ image (Fig. 5b). The rating results are as follows:

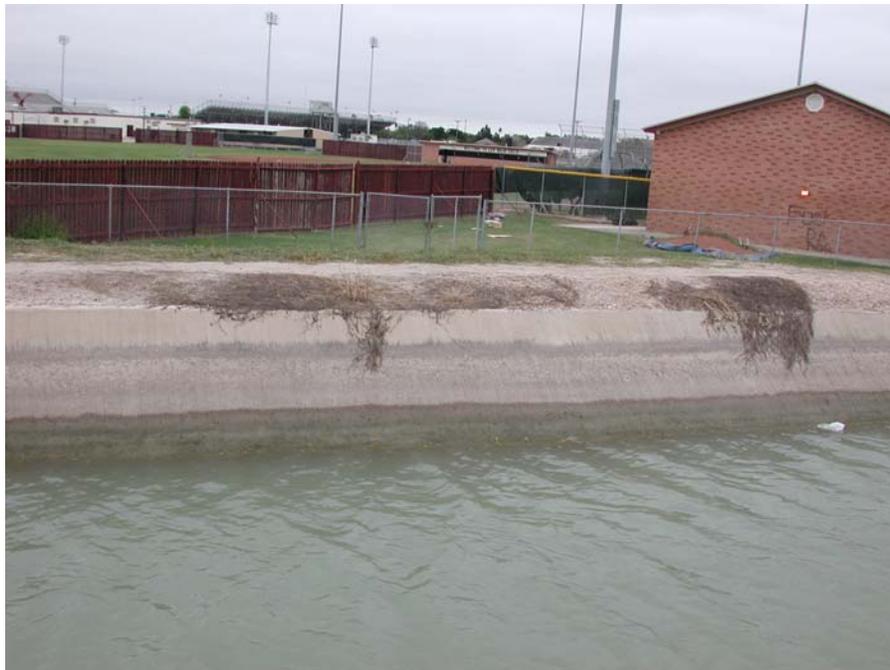
Figure 5c. Site 4 – Photograph showing the dead grass along the canal and that the canal segment is in good condition

The photograph (Fig. 5c) shows some dead vegetations spread over the sides of the canal, but otherwise the conditions of the canal is good. This canal segment does not have a detectable leak.

***Conclusion: this canal segment is unlikely to have a leak.***

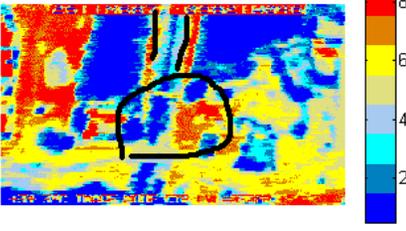
Site 5 - Image 10 at (2611N687, 09821W046)

<p>Investigate:</p> <ul style="list-style-type: none"> <li>• Leakage or thick vegetation at the circled spot</li> <li>• Seepage, vegetation, or shadow at the lined areas</li> </ul>
---	--

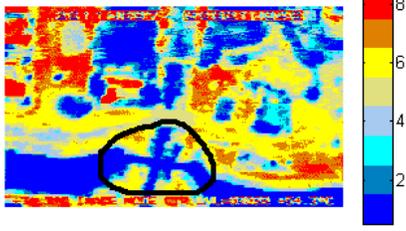
Site 6 - Image 11 at (2611N687, 09821W046)

<p>Investigate:</p> <p>Junction leakage at the circled spot</p>
---	---

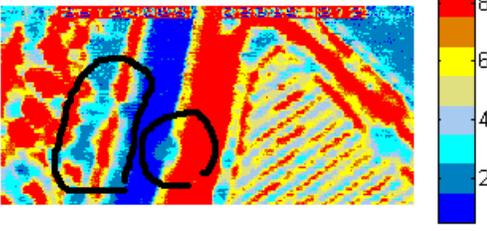
Site 7 - Image 18 at (2612N026, 09820W212)

<p>Investigate:</p> <p>Leakage or vegetation at the circled spots</p>
---	---

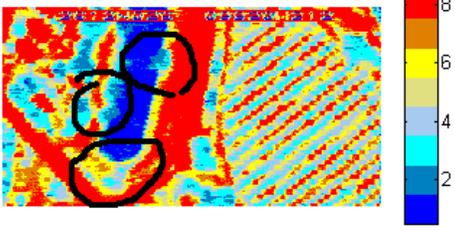
Site 8 - Image 19 at (2612N026, 09820W212)

<p>Investigate:</p> <p>Leakage or vegetation at the circled spots</p>
---	---

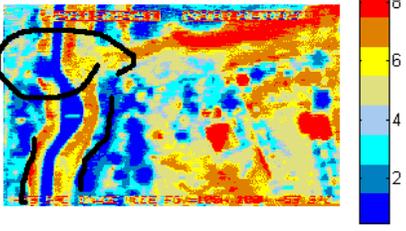
Site 33 - Image 81 at (2615N941, 09819W893)

<p>Investigate:</p> <ul style="list-style-type: none"> <li>• Leakage or thick vegetation at the circled spot</li> <li>• Seepage, vegetation, or shadow at the lined areas</li> </ul>
---	--

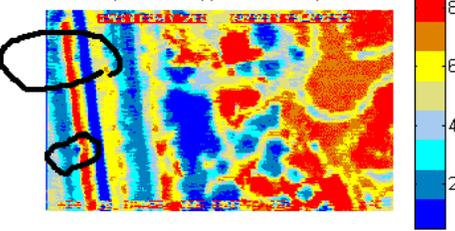
Site 34 - Image 83 at (2616N176, 09819W926)

<p>Investigate:</p> <p>Leakage or thick vegetation at the circled spots</p>
---	---

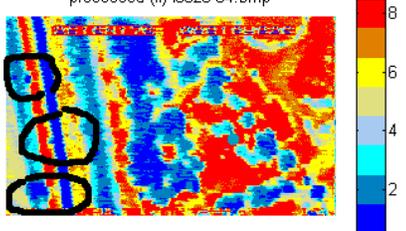
Site 35 - Image 84 at (2616N176, 09819W926)

<p>Investigate:</p> <p>Leakage or thick vegetation at the circled spots</p>
---	---

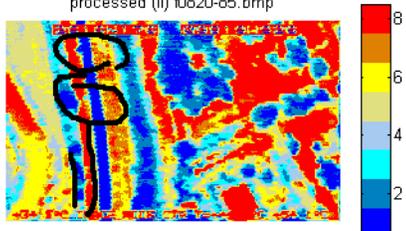
Site 36 - Image 85 at (2616N176, 09819W926)

<p>Investigate:</p> <ul style="list-style-type: none"> <li>• Leakage or thick vegetation at the circled spots</li> <li>• Seepage, vegetation, or shadow at the lined areas</li> </ul>
---	---
