# **Seepage Loss Test Results**

## **In Cameron County Irrigation District No. 2<sup>1</sup>**

Report Prepared for  
Cameron County Irrigation District No. 2

December 18, 2002

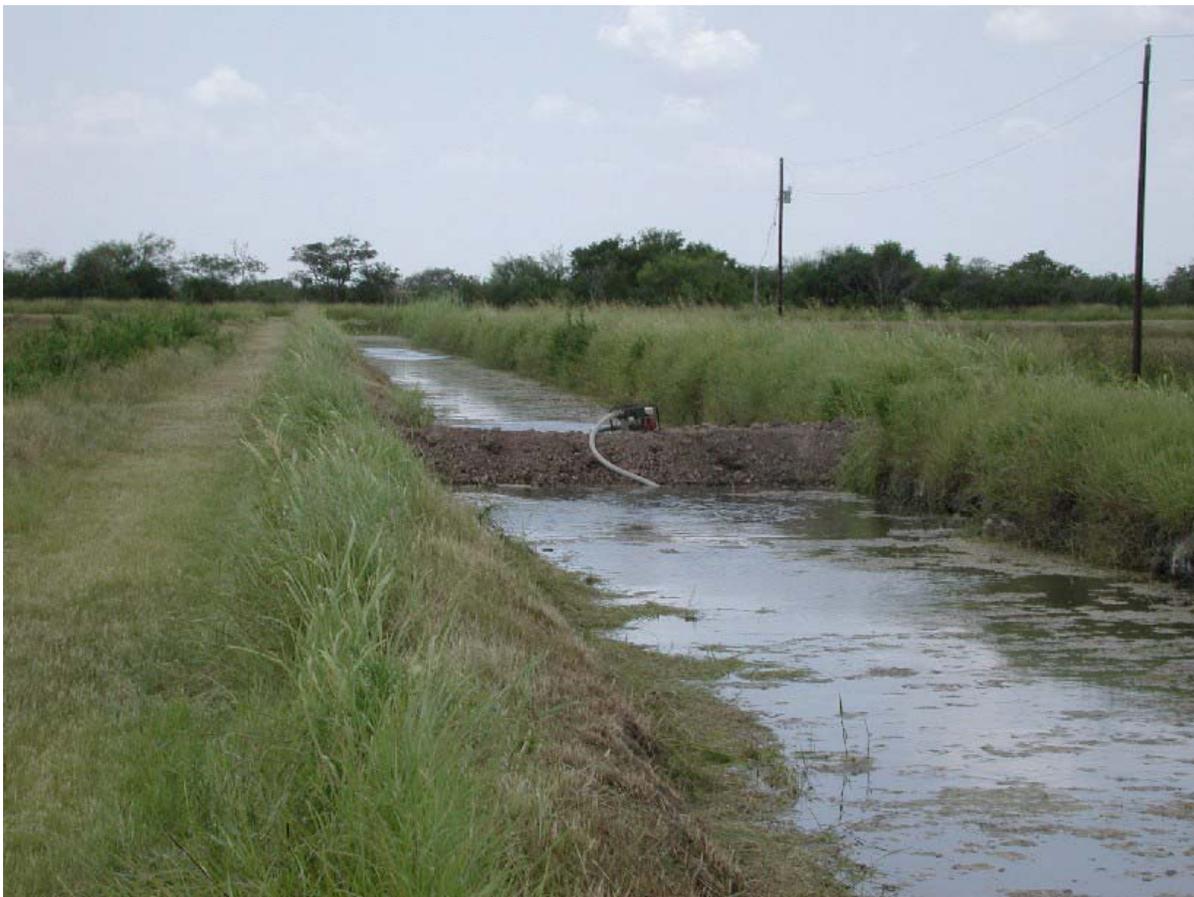
Figure 1. Earthen dam constructed on canal 55.

Loss rates were determined using the ponding method. In this method, the two ends of a canal segment are closed or sealed with earthen dams (Fig. 1), as are any valves or gates located in the test segment. Changes in water levels are recorded for at least 48 hours. One to three continuous-stage level recorders (Fig. 2) were used to supplement the 3 locations where stage levels were recorded manually. During the tests, canal dimensions and water span were also record and surveyed.

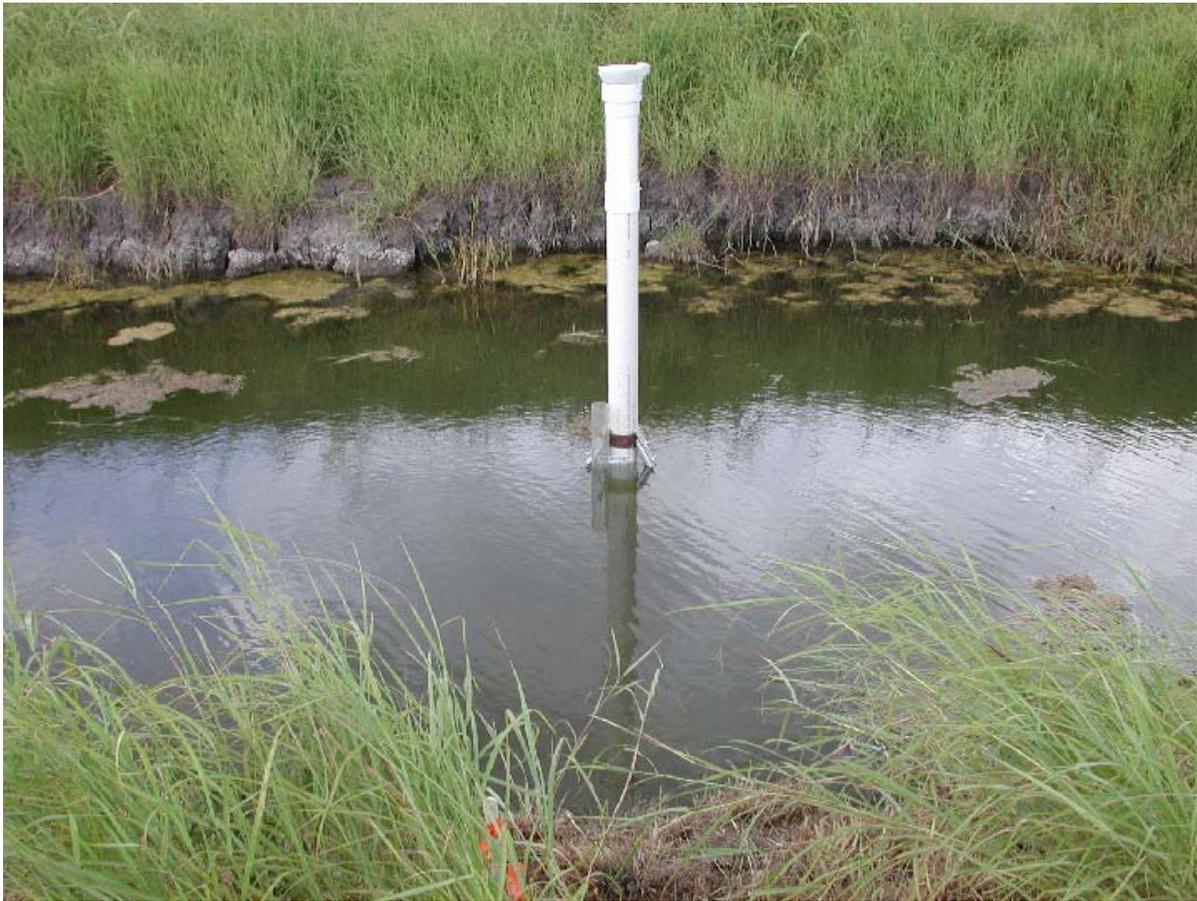
**Figure 2. Continuous-stage level recorders on canal 55.**

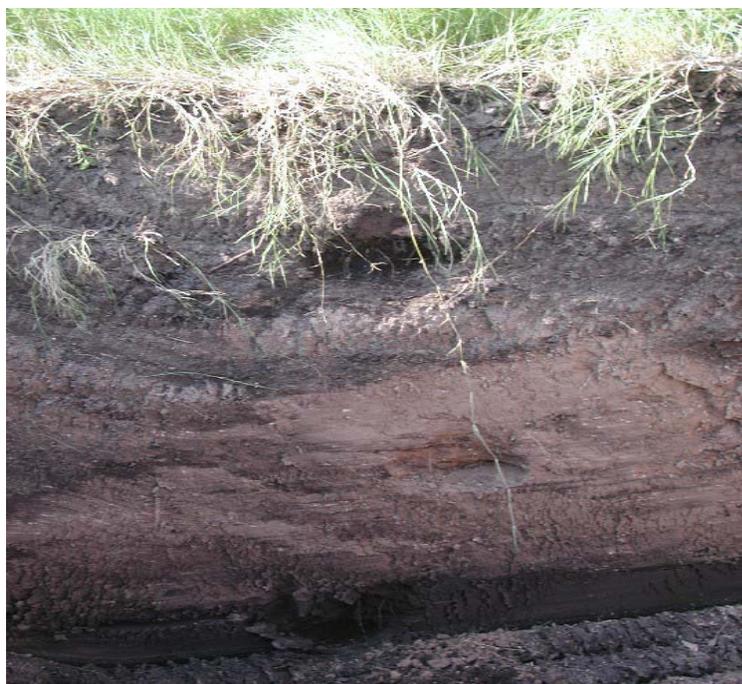
Figure 12. Canal levee soil profile on canal 23.

Two soil samples were taken of the canal embankment (or levee) and one in a field adjacent to the canal. One canal embankment (levee) sample was from inside the canal at or below the normal operating water level, and the other at a location approximately 10 ft from the edge of the canal and 2 feet below the surface. Natural surrounding soil samples were taken in fields adjacent to the test area down to 12 foot of depth. In these tests, shallow groundwater was not found within 12 feet of the soil surface.
