**Thermal Imaging of Canals for  
Remote Detection of Leaks:  
Evaluation in the United Irrigation District<sup>1</sup>**

Yanbo Huang and Guy Fipps, P.E.<sup>2</sup>

December 20, 2002

## **Thermal Imaging of Canals for Remote Detection of Leaks: Evaluation in the United Irrigation District**

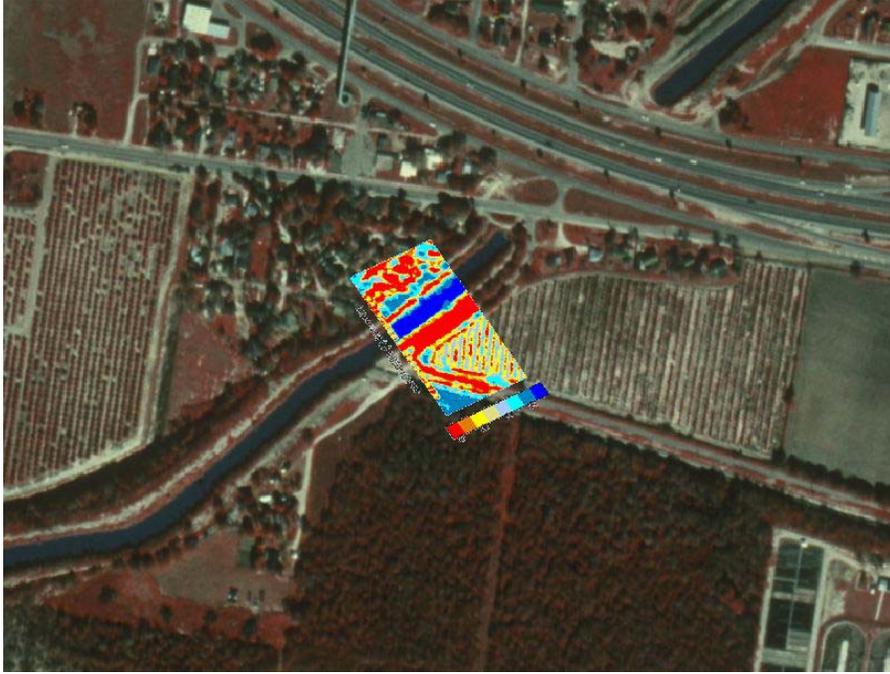
Figure 2b. Site 1 – Inverted image, overlaid onto the DOQQ.

To help locate the site, the image was inverted and overlaid onto the DOQQ image (Fig. 2b). The results of the field rating were as follows:

Photographs taken at this location show a large tree and the dirt road on the same side of the canal (Fig. 2c). Water appears to be flowing out of the canal through a large hole located near the tree. Figure 2d shows thick vegetation (grasses and bushes) with a narrow stripe of dirt road. The site evaluation matched very well our interpretation of the thermal imagery.

***Conclusion: this canal segment has a severe seepage problem at this location caused by a hole in the canal..***

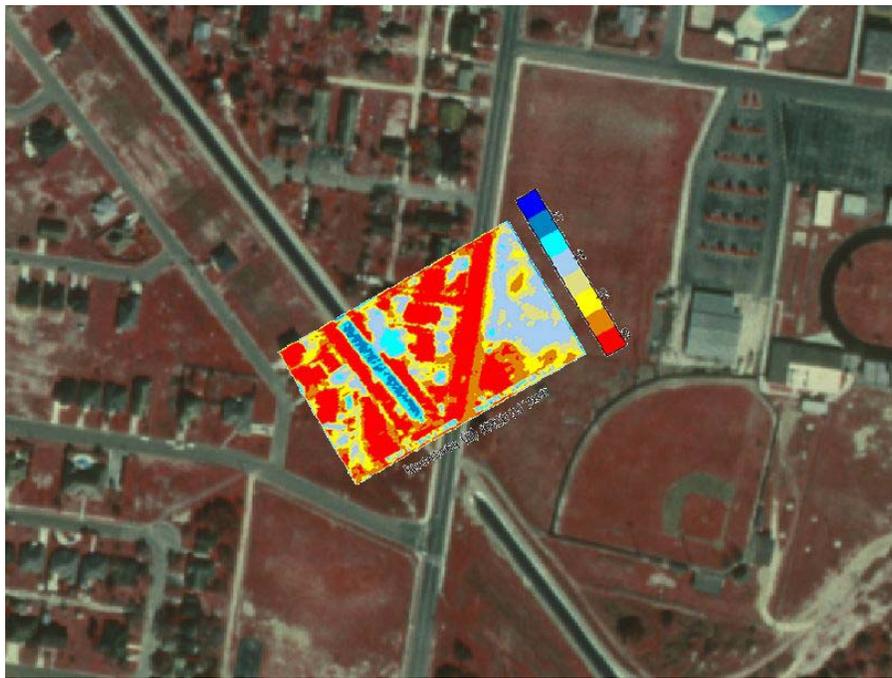
Figure 3b. Site 2 – thermal image inverted and overlaid onto the DOQQ.

As shown in Figure 3a, the thermal image shows two areas of wetness (mark circled on the image) on either side of the canal. Figure 3b shows the inverted image overlaid onto the DOQQ (figure 3b). The results of the field evaluation are as follows:

Site photographs (Fig. 3c-d) show a structure on the side of the canal which appears to be an abandoned gate through which water is flowing. As this is the only place along the canal with thick vegetation, the abandoned gate is likely the only source of the leak.

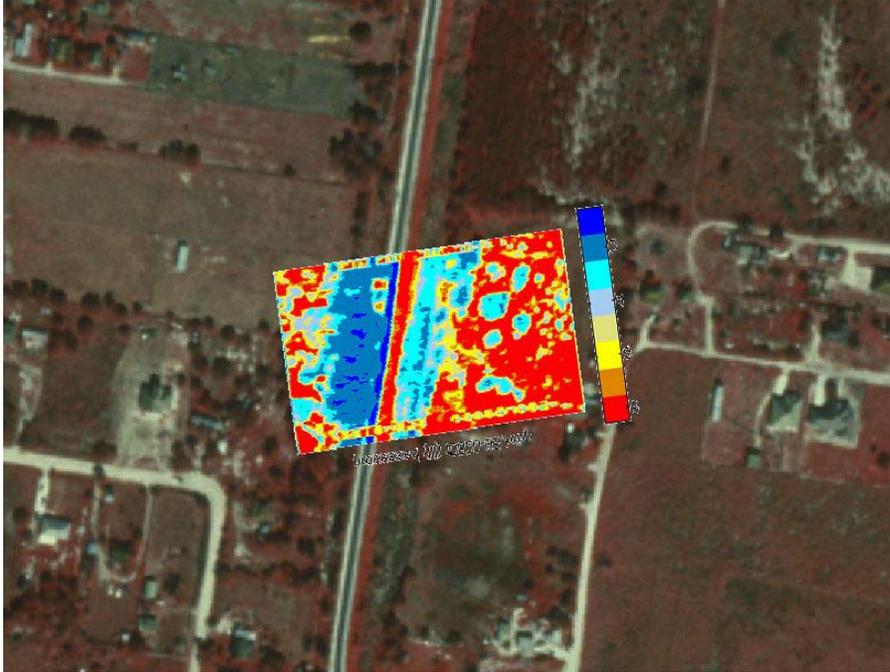
Figure 4b. Site 3 – Inverted thermal image, overlaid onto the DOQQ.

As shown in figure 4a, there is likely a seepage area along one side of the canal (left side on the image). The rating of this site is as follows:

The field photograph (Fig. 4c) shows thick vegetation on the side of the canal having and many cracks. Some of the cracks are sealed but others are not. These unsealed cracks appear to be the cause of the seepage from this canal segment.

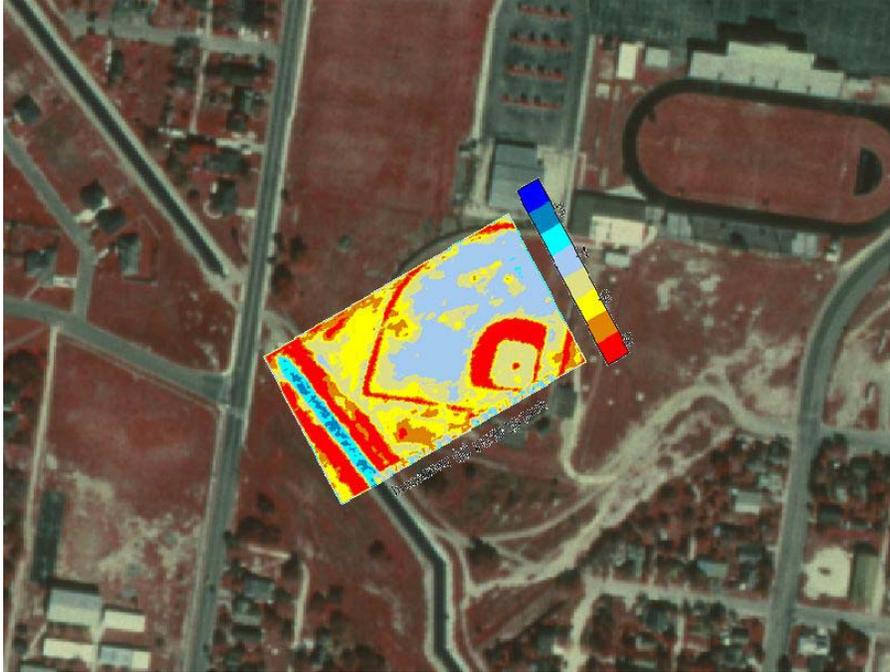
Figure 5b. Site 4 - inverted and overlaid onto DOQQ.

Figure 5a shows a canal segment beside a baseball field. While there is no indication of vegetation or wet areas along this segment, there is something other than a dirt road (line-marked on the image). This image was inverted and overlaid on the DOQQ image (Fig. 5b). The rating results are as follows:

The photograph (Fig. 5c) shows some dead vegetations spread over the sides of the canal, but otherwise the conditions of the canal is good. This canal segment does not have a detectable leak.
