POTENTIAL EVAPOTRANSPIRATION FOR IRRIGATION WATER MANAGEMENT IN URBAN LANDSCAPES - THE SAN ANTONIO EXPERIENCE

C.N. Pope and G. Fipps¹

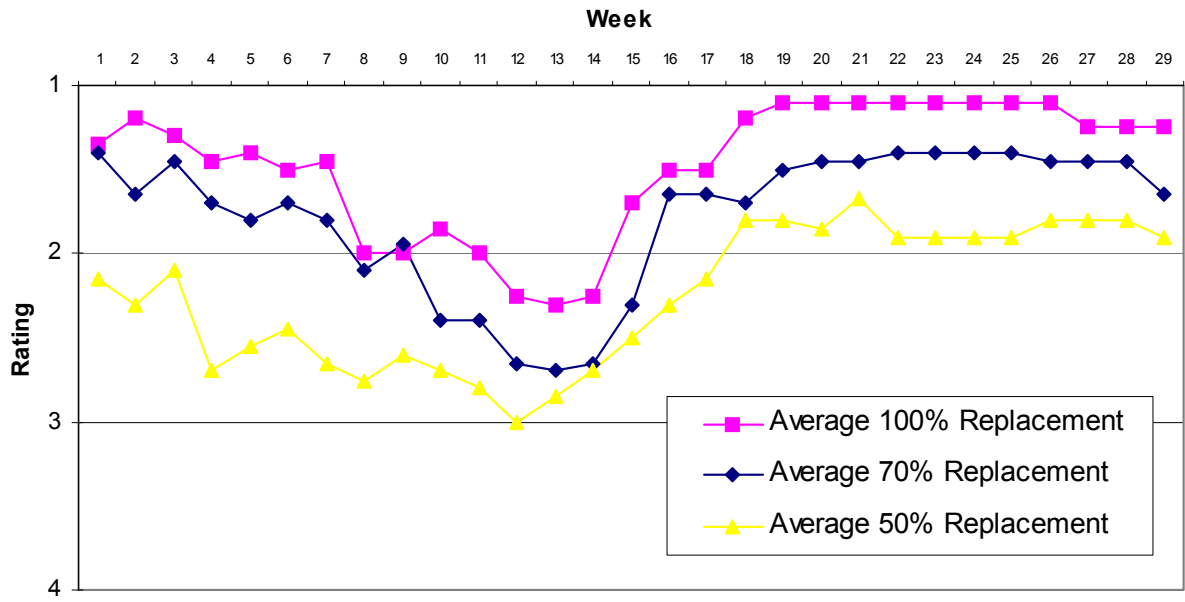
St. Augustine Home Owner Ratings By Replacement Rate Summer 1998

Figure 1 shows the quality rating for St. Augustine for all three watering treatments: replacing 100%, 70%, and 50% of TIR. The quality ratings in all three treatments fell during the summer months as expected. The quality ratings for St. Augustine at 100% TIR showed a lower summer decline and quicker autumn recovery to higher ratings than at the beginning of the season. At all levels of irrigation, St. Augustine eventually returned to at least its original rating.
